Preservation Briefs: National Park Service

Preservation Briefs: Assessing Cleaning and Water Repellent Treatments for Historic Masonry Buildings

Assessing Cleaning and Water-Repellent Treatments for Historic Masonry Buildings

U.S. Department of the Interior
National Park Service
Cultural Resources
Heritage Preservation Services

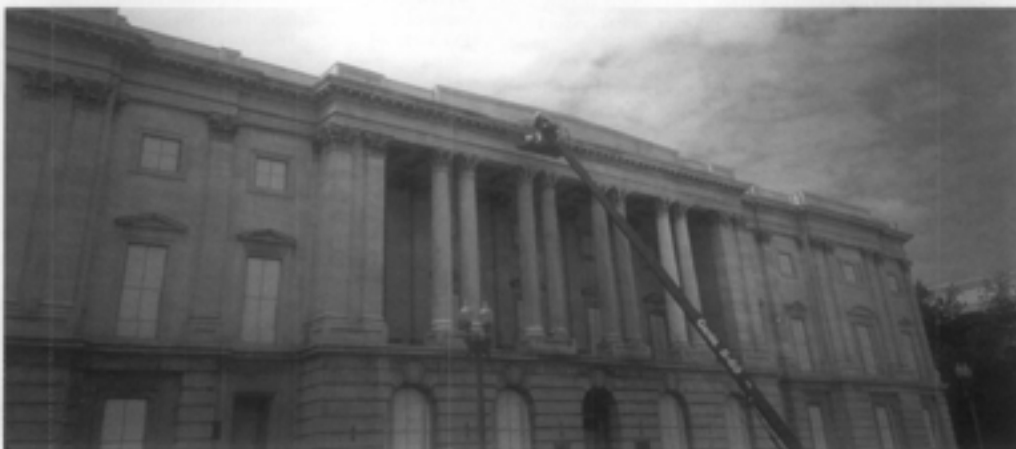
Figure 1. Low-to medium-pressure steam (hot-pressurized) water washing, is being used to clean the exterior of the U.S. Tariff Commission Building, the first marble building constructed in Washington, D.C., in 1839. This method was selected by an architectural conservator as the "gentlest means possible" to clean the marble. Steam can soften heavy soiling deposits such as those on the cornice and column capitals, and facilitate easy removal. Note how these deposits have been removed from the right side of the cornice which has already been cleaned.

The Brief is intended to help develop sensitivity to the qualities of historic masonry that makes it so special, and to assist historic building owners and property managers in working cooperatively with architects, architectural conservators and contractors (Fig. 1). Although specifically intended for historic buildings, the information is applicable to all masonry buildings. This publication updates and expands *Preservation Brief 1: The Cleaning and Waterproof Coating of Masonry Buildings*. The Brief is not meant to be a cleaning manual or a guide for preparing specifications. Rather, it provides general information to raise awareness of the many factors involved in selecting cleaning and water-repellent treatments for historic masonry buildings.

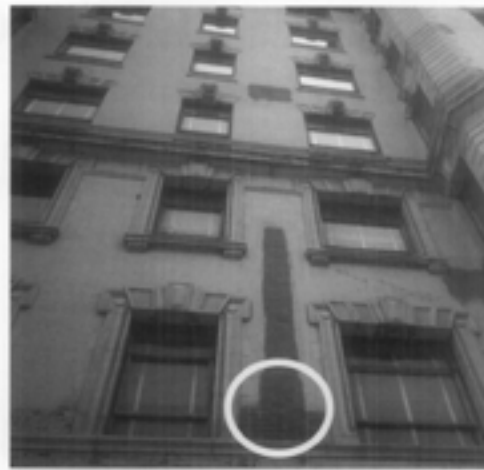
Figure 3. This small test area has revealed a red brick patch that does not match the original beige brick. This may explain why the building was painted, and may suggest to the owner that it may be preferable to keep it painted.

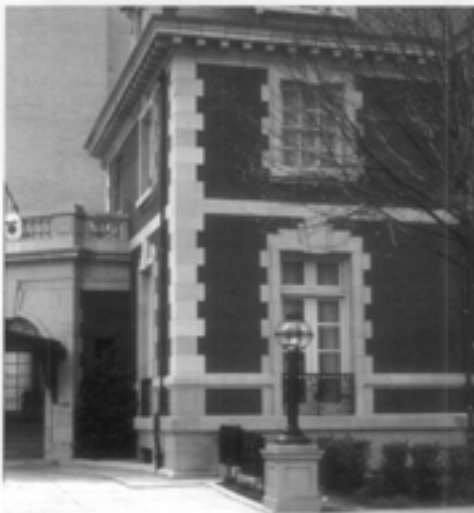
Figure 4. The foundation of this brick building is limestone, but the decorative trim above is architectural terra cotta intended to simulate stone.

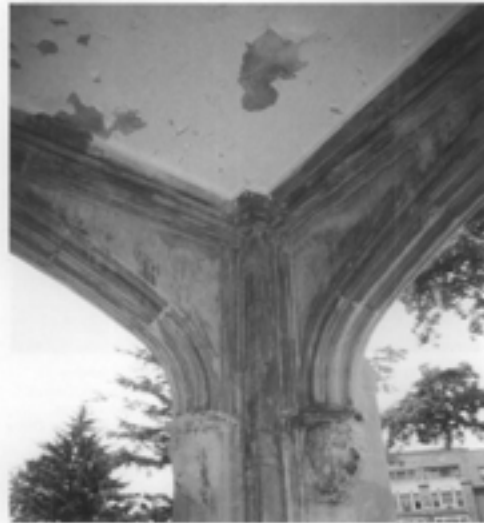
Figure 5. Repeated water washing did not remove the staining inside this limestone porte cochere. Upon closer examination, it was determined to be a water-repellent coating that had been applied many years earlier. An alkaline cleaner may be effective in removing it.

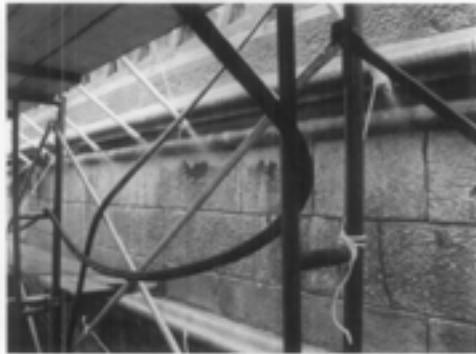
Figure 6. Timed water soaking can be very effective for cleaning limestone and marble as shown here at the Marble Collegiate Church in New York City. In this case, a twelve-hour water soak using a multi-nozzle manifold was followed by a final water rinse. Photo: Diane S. Kaese, Wiss, Janney, Elstner Associates, Inc., N.Y., N.Y.

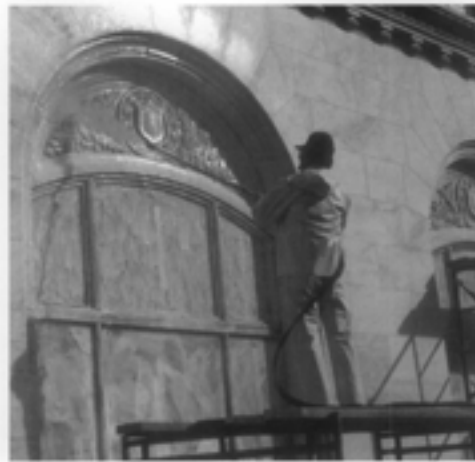
Figure 7. Glazed architectural terra cotta often may be cleaned successfully with a low-pressure water wash and hand scrubbing supplemented, if necessary, with a non-ionic detergent. Photo: National Park Service Files.

Water Washing. Washing with low-pressure or medium-pressure water is probably one of the most commonly used methods for removing dirt or other pollutant soiling from historic masonry buildings (Fig. 7). Starting with a very low pressure (100 psi or below), even using a garden hose, and progressing as needed to slightly higher pressure—generally no higher than 300-400 psi—is always the recommended way to begin. Scrubbing with natural bristle or synthetic bristle brushes—never metal which can abrade the surface and leave metal particles that can stain the masonry—can help in cleaning areas of the masonry that are especially dirty.

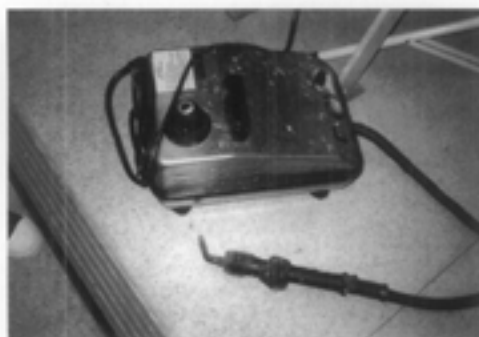
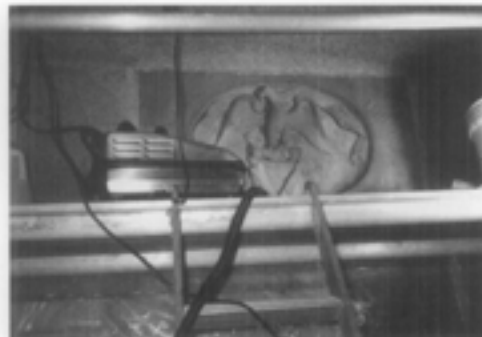
Figure 9. (Left) This small steam cleaner—the size of a vacuum cleaner—offers a very controlled and gentle means of cleaning limited, or hard-to-reach areas or carved stone details. (Right) It is particularly useful for interiors where it is important to keep moisture to a minimum, such as inside the Washington Monument, Washington, D.C., where it was used to clean the commemorative stones. Photos: Audrey T. Tepper.

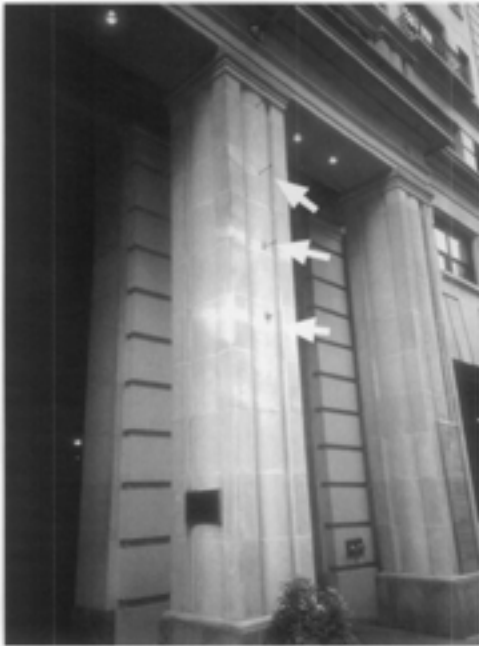
Figure 10. High-pressure water washing too close to the surface has abraded and, consequently, marred the limestone on this early-20th century building.

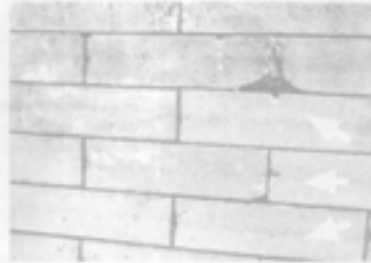
Figure 11. Rinsing with high-pressure water following chemical cleaning has left a horizontal line of abrasion across the bricks on this late-19th century row house.

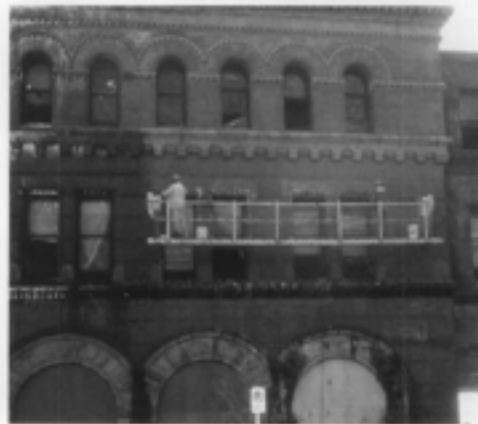
Figure 12. A mild acidic cleaning agent is being used to clean this heavily soiled brick and granite building. Additional applications of the cleaner and hand-scrubbing, and even poulticing, may be necessary to remove the dark stains on the granite arches below. Photo: Sharon C. Park, FAIA.

Acidic Cleaners. Acid-based cleaning products may be used on **non-acid sensitive** masonry, which generally includes: granite, most sandstones, slate, unglazed brick and unglazed architectural terra cotta, cast stone and concrete (Fig. 12). Most commercial acidic cleaners are composed primarily of hydrofluoric acid, and often include some phosphoric acid to prevent rust-like stains from developing on the masonry after the cleaning. Acid cleaners are applied to the pre-wet masonry which should be kept wet while the acid is allowed to “work”, and then removed with a water wash.

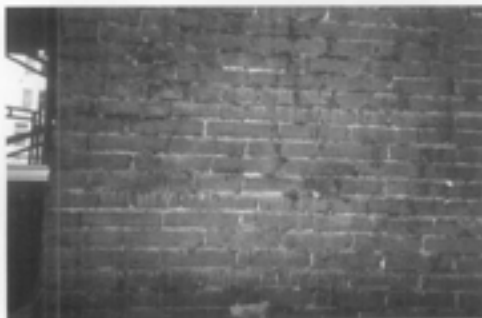
Figure 13. Sometimes it may be preferable to paint over a thick asphaltic coating rather than try to remove it, because it can be difficult to remove completely. However, in this case, many layers of asphaltic coating were removed through multiple applications of a heavy duty chemical cleaner. Each application of the cleaner was left to dwell following the manufacturer's recommendations, and then rinsed thoroughly. (As much as possible of the asphalt was first removed with wooden scrapers.) Although not all the asphalt was removed, this was determined to be an acceptable level of cleanliness for the project.

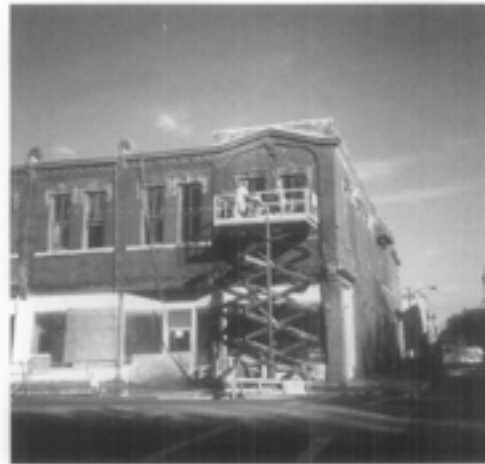
Figure 14. Chemical removal of paint from this brick building has revealed that the cornice and window hoods are metal rather than masonry.

Other Paint Removers and Cleaners. Other cleaning compounds that can be used to remove paint and some painted graffiti from historic masonry include paint removers based on N-methyl-2-pyrrolidone (NMP), or on petroleum-based compounds. Removing stains, whether they are industrial (smoke, soot, grease or tar), metallic (iron or copper), or biological (plant and fungal) in origin, depends on carefully matching the type of remover to the type of stain (Fig. 13). Successful removal of stains from historic masonry often requires the application of a number of different removers before the right one is found. The removal of layers of paint from a masonry surface is usually accomplished by applying the remover either by brush, roller or spraying, followed by a thorough water wash (Fig. 14).

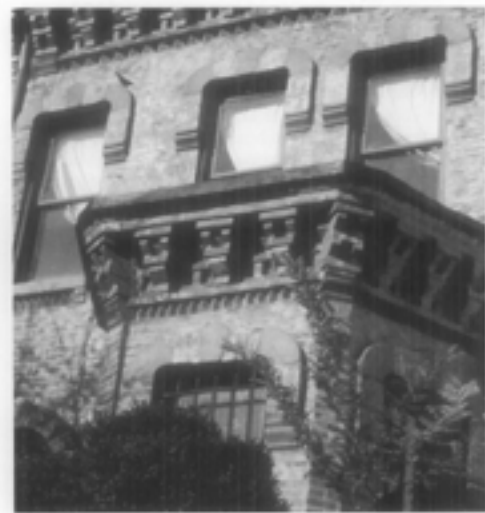
Figure 15. The whitish deposits left on the brick by a chemical paint remover may have resulted from inadequate rinsing or from the chemical being left on the surface too long and may be impossible to remove.

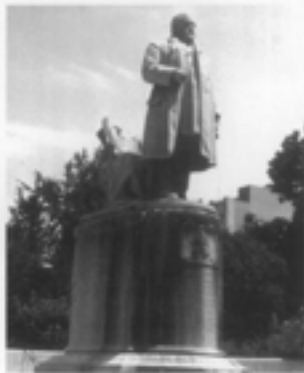
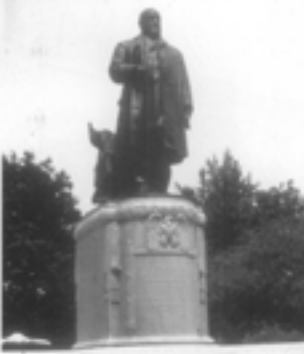
Figure 16. (a) The limestone base was heavily stained by runoff from the bronze statue above. (b) A poultice consisting of copper stain remover and ammonia mixed with fuller's earth was applied to the stone base and covered with plastic sheeting to keep it from drying out too quickly. (c) As the poultice dried, it pulled the stain out of the stone. (d) The poultice residue was removed carefully from the stone surface with wooden scrapers and the stone was rinsed with water. Photos: John Dagger.

Graffiti and stains, which have penetrated into the masonry, often are best removed by using a poultice. A poultice consists of an absorbent material or clay powder (such as kaolin or fuller's earth, or even shredded paper or paper towels), mixed with a liquid (solvent or other remover) to form a paste which is applied to the stain (Figs. 16-17). As it dries, the paste absorbs the staining material so that it is not redeposited on the masonry surface. Some commercial cleaning products and paint removers are specially formulated as a paste or gel that will cling to a vertical surface and remain moist for a longer period of time in order to prolong the action of the chemical on the stain. Pre-mixed poultices are also available as a paste or in powder form needing only the addition of the appropriate liquid. The masonry must be pre-wet before applying an alkaline cleaning agent, but not when using a solvent. Once the stain has been removed, the masonry must be rinsed thoroughly.

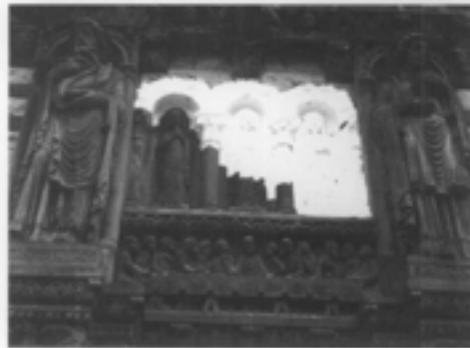
Figure 17. A poultice is being used to remove salts from the brownstone statuary on the facade of this late-19th century stone church. Photo: National Park Service Files.

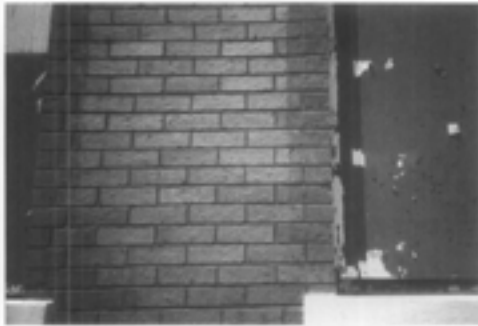
Figure 18. The glazed bricks in the center of the pier were covered by a signboard that protected them from being damaged by the sandblasting which removed the glaze from the surrounding bricks.

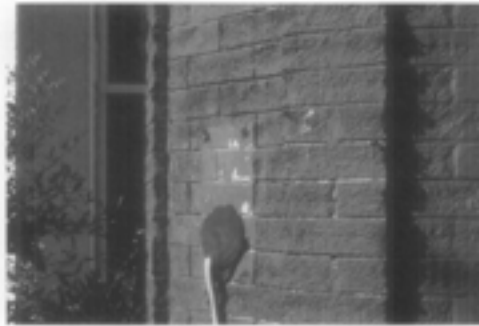
Figure 19. A comparison of undamaged bricks surrounding the electrical conduit with the rest of the brick facade emphasizes the severity of the erosion caused by sandblasting.

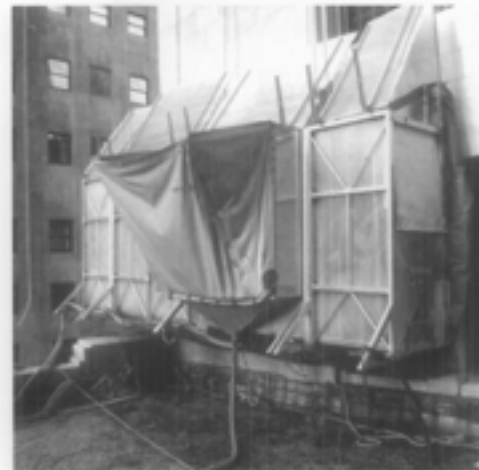
Figure 20. (Left) A comparison of the limestone surface of a 1920s office building before and after “cleaning” with a proprietary abrasive process using fine glass powder clearly shows the effectiveness of this method. But this is an abrasive technique and it has “cleaned” by removing part of the masonry surface with the dirt. Because it is abrasive, it is generally not recommended for large-scale cleaning of historic masonry, although it may be suitable to use in certain, very limited cases under controlled circumstances. (Right) A vacuum chamber where the used glass powder is collected for environmentally safe disposal is a unique feature of this particular process. The specially-trained operators in the chamber wear protective clothing, masks and breathing equipment. Photos: Tom Koehn.

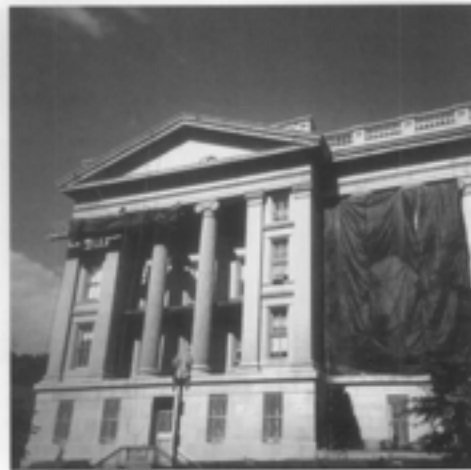
Figure 23. A tarpaulin protects and shields pedestrians from potentially harmful spray while chemical cleaning is underway on the granite exterior of the U.S. Treasury Building, Washington, D.C.

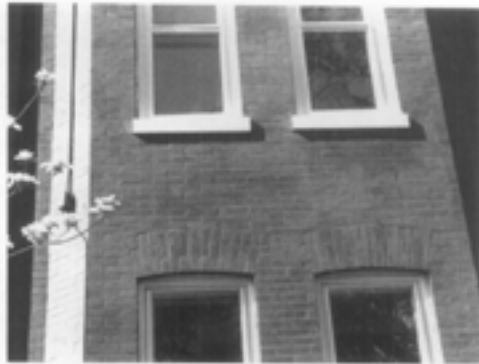
Figure 24. Although the application of a water-repellent coating was probably not needed on either of these buildings, the coating on the brick building (above), is not visible and has not changed the character of the brick. But the coating on the brick column (below), has a high gloss that is incompatible with the historic character of the masonry.

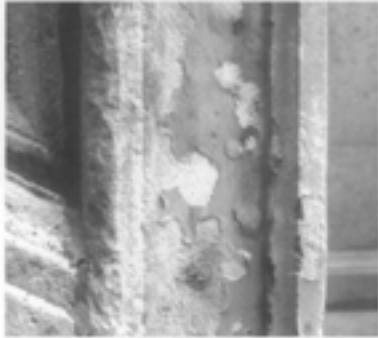
Figure 25. The clear coating applied to this limestone masonry has failed and is taking off some of the stone surface as it peels. Photo: Frances Gale.

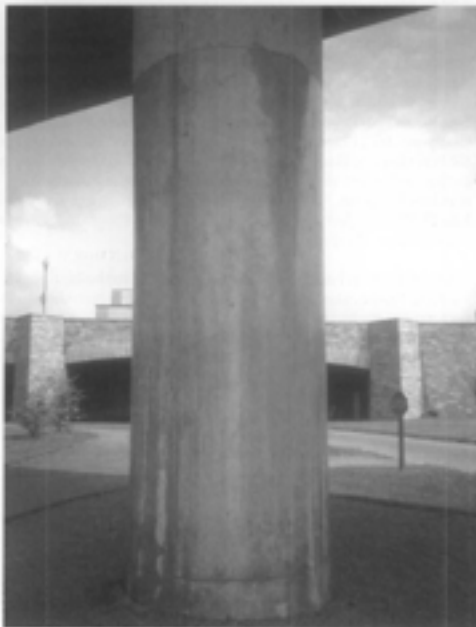
Figure 26. The anti-graffiti or barrier coating on this column is very shiny and would not be appropriate to use on a historic masonry building. The coating has discolored as it has aged and whitish streaks reveal areas of bare concrete where the coating was incompletely applied.

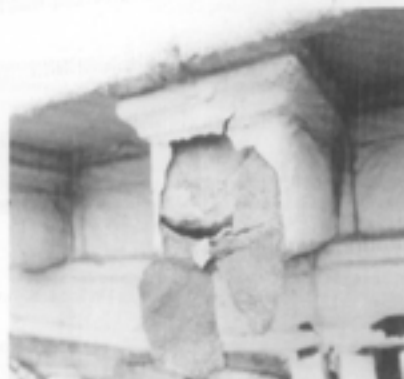
Figure 27. Instead of correcting the roof drainage problems, an elastomeric coating was applied to the already saturated limestone cornice. An elastomeric coating holds moisture in the masonry because it does not "breathe" and does not allow liquid moisture to escape. If the water pressure builds up sufficiently it can cause the coating to break and pop off as shown in this example, often pulling pieces of the masonry with it. Photo: National Park Service Files.

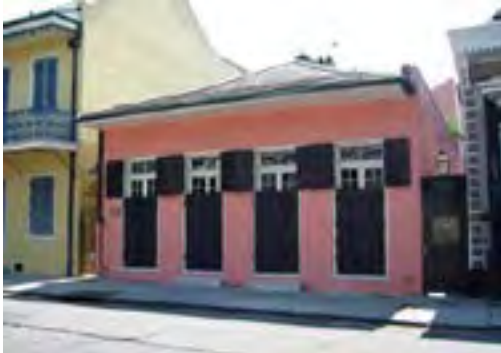
Fig. 2. Upper and lower shutters control daylight and provide privacy.

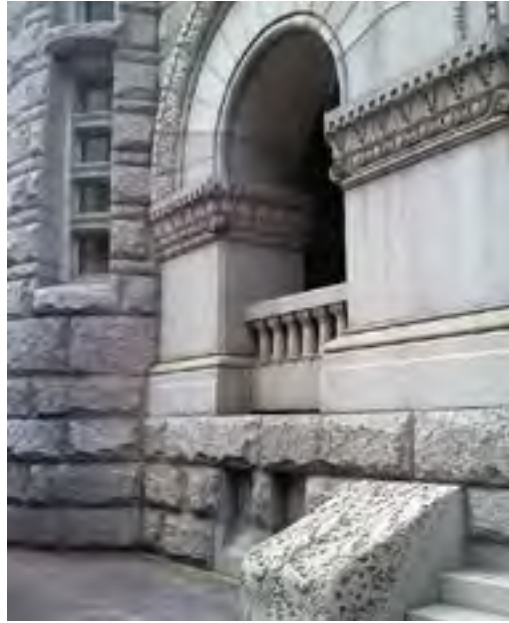
Fig. 3. Stone walls with substantial mass have high thermal inertia.

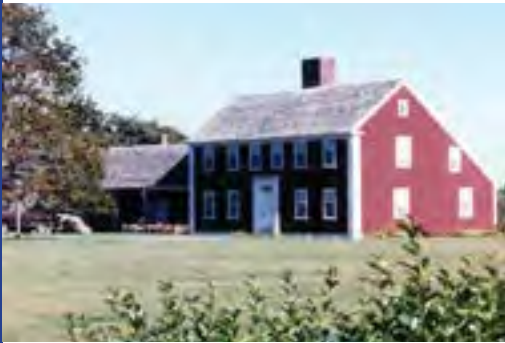
Fig. 4. A typical New England saltbox features a steeply sloping roof to shed snow and a floor plan organized around a central chimney to conserve heat.

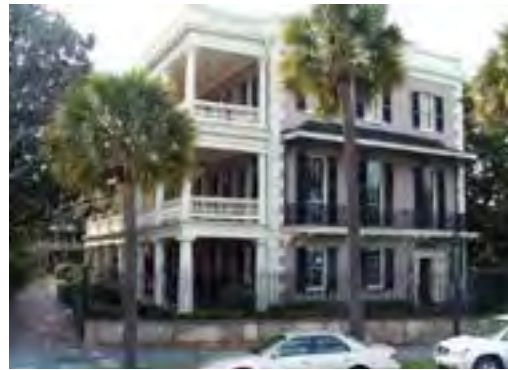
Fig. 5. The side porches of this house in Charleston, SC, shade the large windows and provide outdoor living spaces that take advantage of sea breezes.

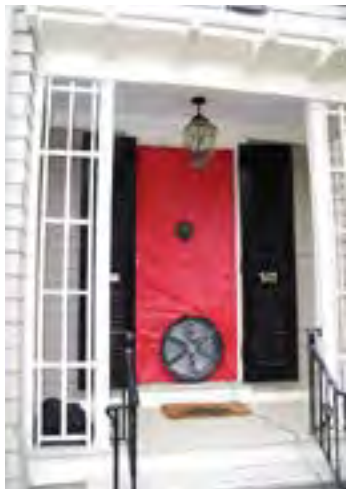
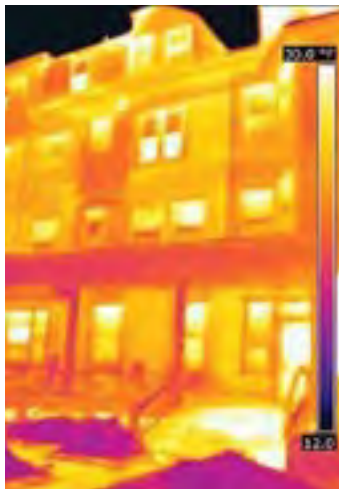
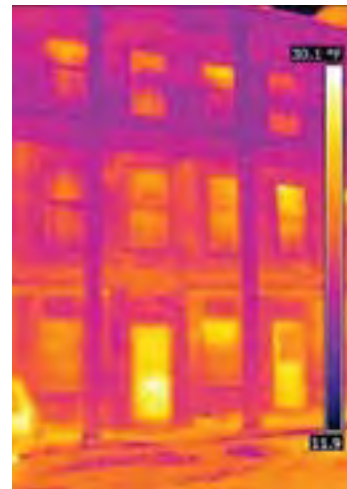
Fig. 6. (left) A blower door is used to depressurize a building by exhausting air at a rate that allows pressure gages and tracer smoke to measure the amount and location of air leakage. Photo: Robert Cagnetta, Heritage Restoration, Inc.

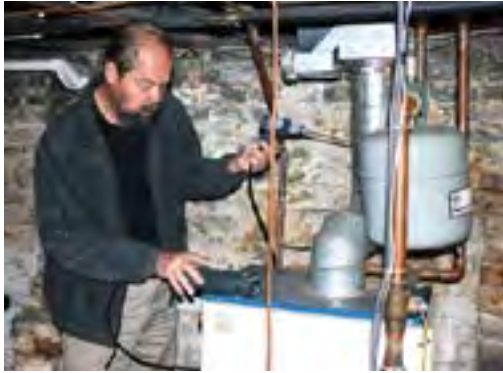
Fig. 9. An energy auditor tests the efficiency of a boiler.

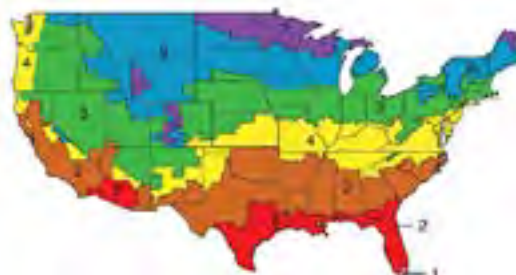
DOE Climate Zone Map

Fig. 12. Recommended energy improvements vary widely based on climate. The information contained in this document is based primarily on the available data for the Northeast and Mid-Atlantic regions.

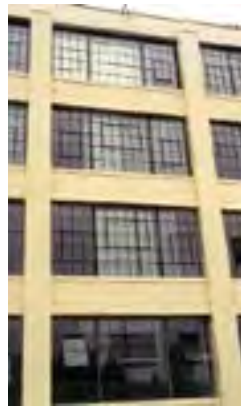
For large, steel industrial windows, the addition of interior, insulated sliding glass windows that align with the primary vertical mullions has proven to be a successful treatment that allows the primary window to remain operable.

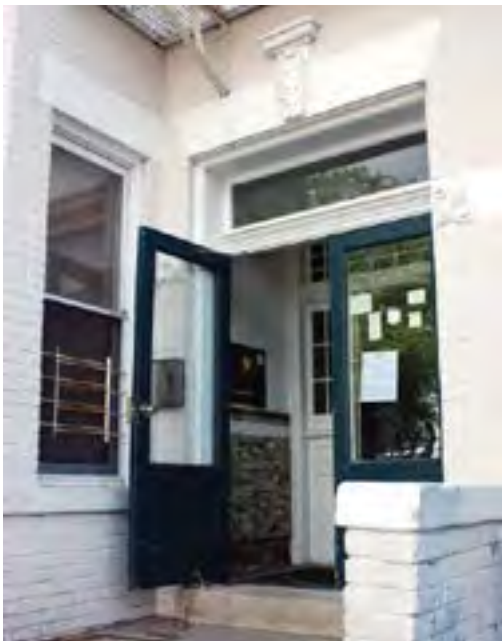
Fig. 16. Historic vestibules retain conditioned air in the living spaces.

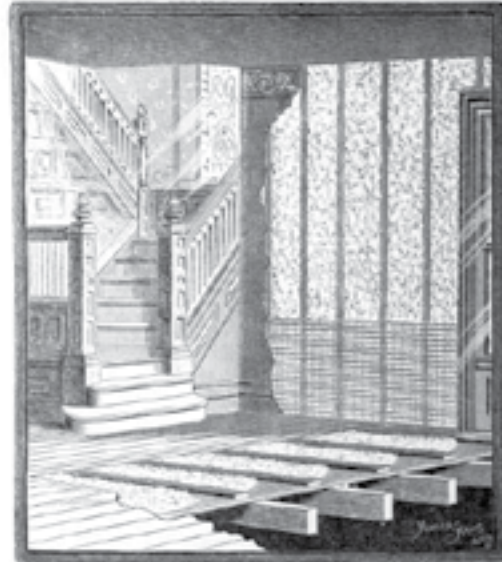
AN INTERIOR

Showing Mineral Wool in Floor, and Walls behind Wire Lath.

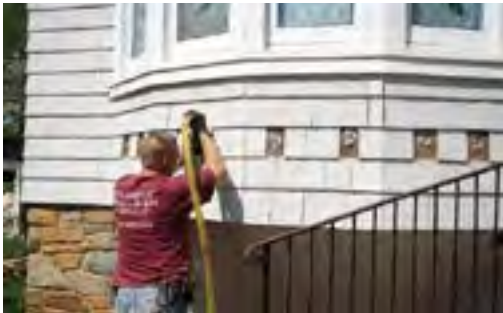
Fig. 18. Dense-packed cellulose insulation is being blown in through holes drilled in the sheathing. Once the operation has been completed, the shingles will be reinstalled. Photo: Edward Minch.

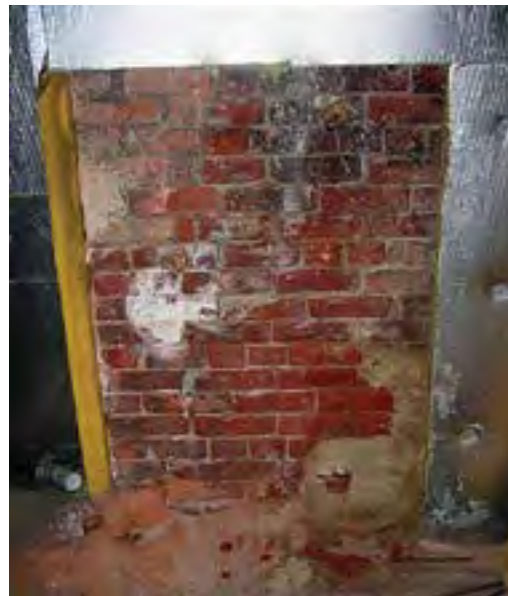
Fig. 21. The interior face of a brick masonry wall shows damage that resulted from the installation of a vapor retardant (foil facing) and thermal insulation. Photo: Simpson Gumpertz & Heger.

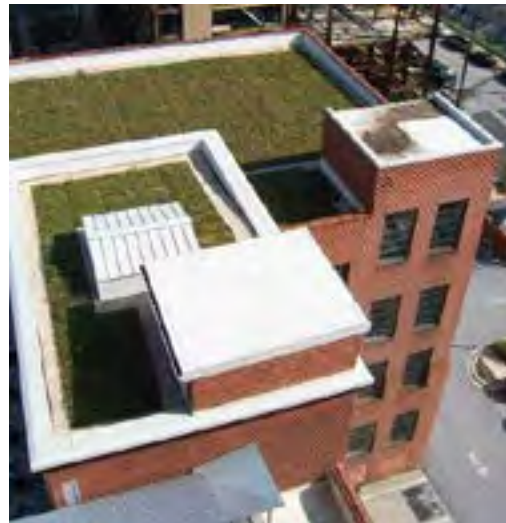
Fig. 22. Installation of both cool and green roofs in an urban environment.

Install cool roofs and green roofs: Cool roofs and vegetated "green roofs" help to reduce the heat gain from the roof, thereby cooling the building and its environment. Cool roofs include reflective metal roofs,

A green roof consists of a thin layer of vegetation planted over a waterproofing system or in trays installed on top of an existing flat or slightly sloped roof. Green roofs are primarily beneficial in urban contexts to reduce the heat island effect in cities and to control storm water run-off. A green roof also reduces the cooling load of the building and helps cool the surrounding urban environment, filters air, collects and filters storm water, and can provide urban amenities, including vegetable gardens, for building occupants. The impact of increased

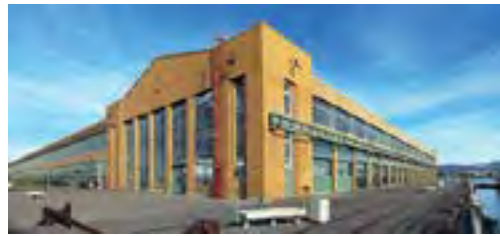
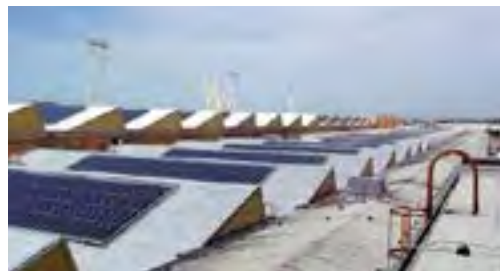
Fig. 23. Solar collectors installed in a compatible manner on low sloping sawtooth monitors. Top Photo: Neil Mishalov, Berkeley, CA.

Solar collectors used to heat water can be relatively simple. More complex solar collectors heat a fluid or air that is then pumped through the system to heat or cool interior spaces. Photovoltaic panels (PV) transform solar radiation into electricity. The greatest potential for the use of PV panels in historic buildings is on buildings with large flat roofs, high parapets, or roof configurations that allow solar panels to be installed without being prominently visible. The feasibility of installing solar devices in small commercial and residential buildings will depend on installation costs, conventional energy rates, and available incentives, all of

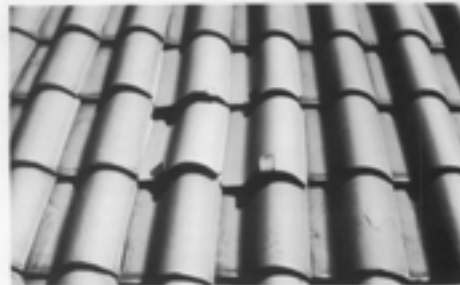
Repairs on this pantile roof were made with new tiles held in place with metal hangers. (Main Building, Ellis Island, New York)

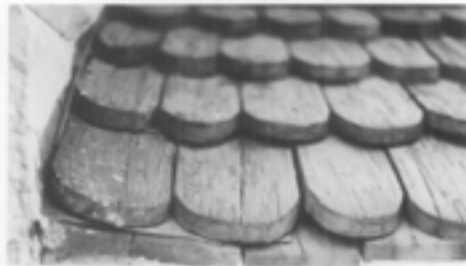
Replacement of particular historic details is important to the individual historic character of a roof, such as the treatment at the eaves of this rounded butt wood shingle roof. Also note that the surface of the roof was carefully sloped to drain water away from the side of the dormer. In the restoration, this function was augmented with the addition of carefully concealed modern metal flashing. (Mount Vernon, Virginia)

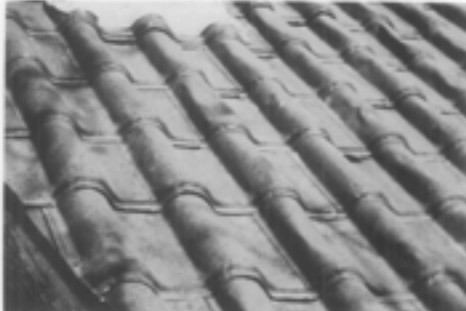
Galvanized sheet-metal shingles imitating the appearance of pantiles remained popular from the second half of the 19th century into the 20th century. (Episcopal Church, now the Jerome Historical Society Building, Jerome, Arizona, 1927)

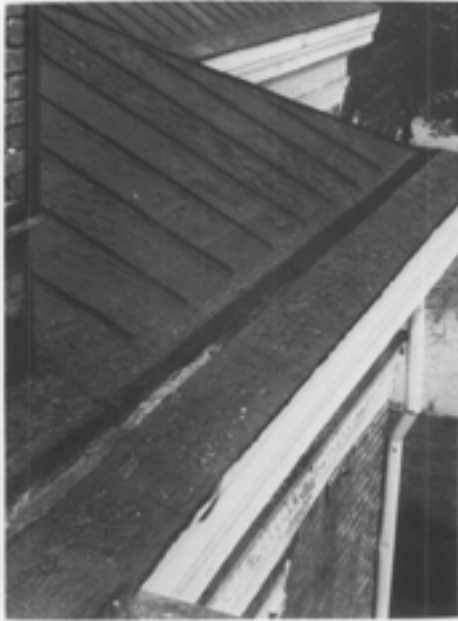
Repeated repair with asphalt, which cracks as it hardens, has created a blistered surface on this sheet-metal roof and built-in gutter, which will retain water. Repairs could be made by carefully heating and scraping the surface clean, repairing the holes in the metal with a flexible mastic compound or a metal patch, and coating the surface with a fibre paint. (Roane County Courthouse, Kingston, Tennessee, photo courtesy of Building Conservation Technology, Inc.)

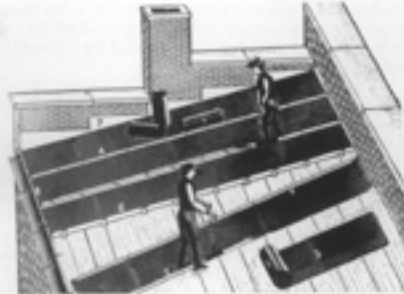
A Chicago firm's catalog dated 1896 illustrates a method of unrolling, turning the edges, and finishing the standing seam on a metal roof.

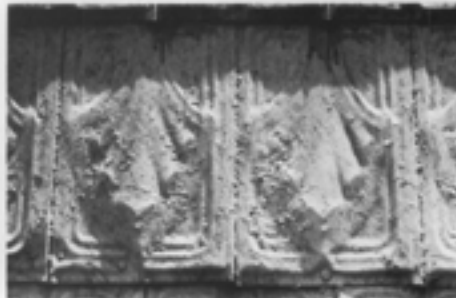
Tin shingles, commonly embossed to imitate wood or tile, or with a decorative design, were popular as an inexpensive, textured roofing material. These shingles 8 1/2 inch by 12 1/2 inch on the exposed surface were designed with interlocking edges, but they have been repaired by surface nailing, which may cause future leakage. (Ballard House, Yorktown, Virginia, photo by Gordie Whitington, National Park Service)

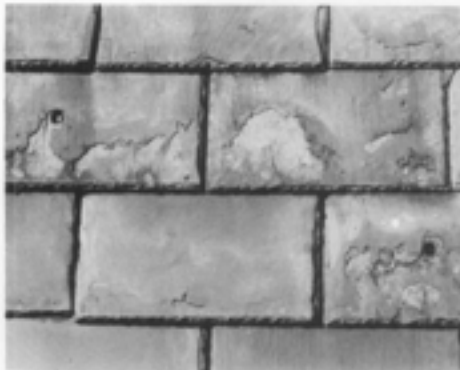
This detail shows slate delamination caused by a combination of weathering and pollution. In addition, the slates have eroded around the repair nails, incorrectly placed in the exposed surface of the slates. (Lower Pontalba Building, New Orleans, photo courtesy of Building Conservation Technology, Inc.)

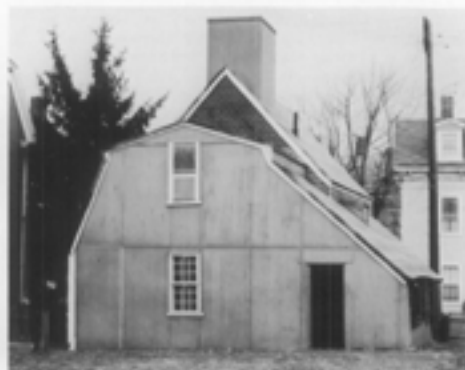
Temporary stabilization or "mothballing" with materials such as plywood and building paper can protect the roof of a project until it can be properly repaired or replaced. (Narbonne House, Salem, Massachusetts)

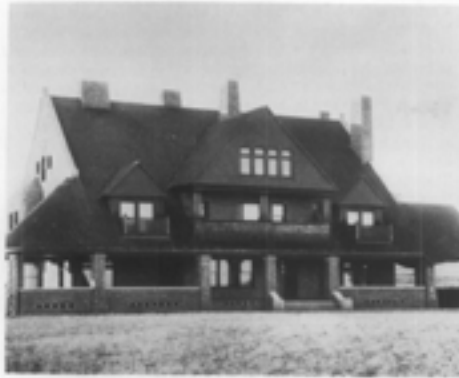
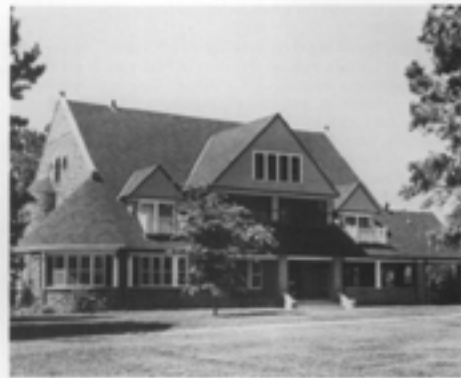
These two views of the same house demonstrate how the use of a substitute material can drastically affect the overall character of a structure. The textural interest of the original tile roof was lost with the use of asphalt shingles. Recent preservation efforts are replacing the tile roof. (Frank House, Kearney, Nebraska, photo courtesy of the Nebraska State Historical Society, Lincoln, Nebraska)

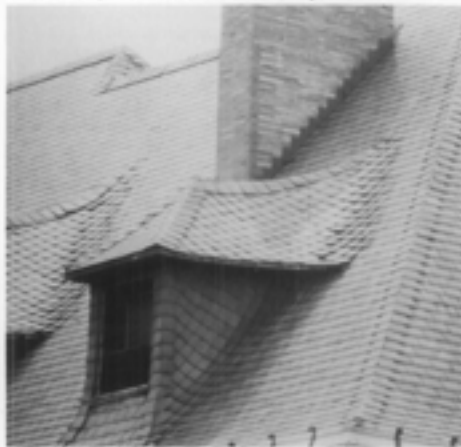
Because of the roof's visibility, the slate detailing around the dormers is important to the character of this structure. Note how the slates swirl from a horizontal pattern on the main roof to a diamond pattern on the dormer roofs and side walls. (18th and Que Streets, NW, Washington, D.C.)

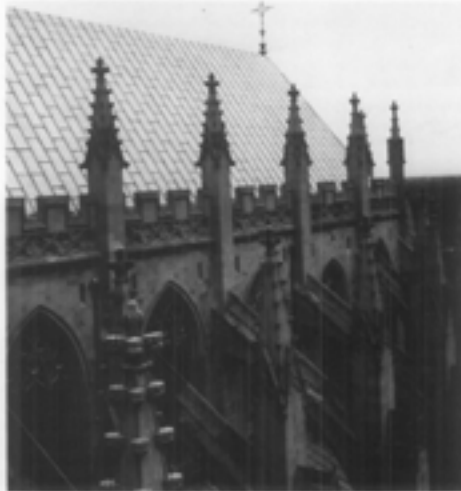
Good design and quality materials for the roof surface, fastenings, and flashing minimize roofing failures. This is essential on roofs such as on the National Cathedral where a thorough maintenance inspection and minor repairs cannot be done easily without special scaffolding. However, the success of the roof on any structure depends on frequent cleaning and repair of the gutter system. (Washington, D.C., photo courtesy of John Burns, A.I.A.)

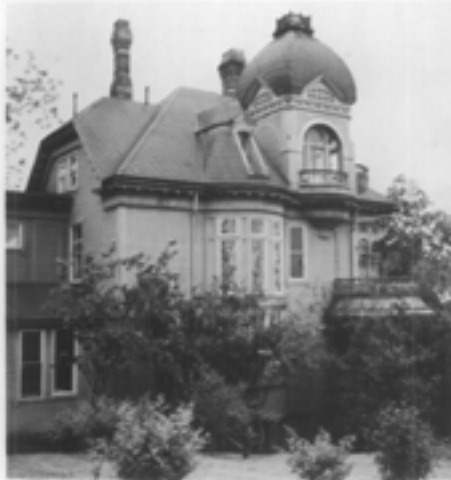
Special problems inherent in the design of an elaborate historic roof can be controlled through the use of good materials and regular maintenance. The shape and detailing are essential elements of the building's historic character, and should not be modified, despite the use of alternative surface materials. (Gamwell House, Bellingham, Washington)

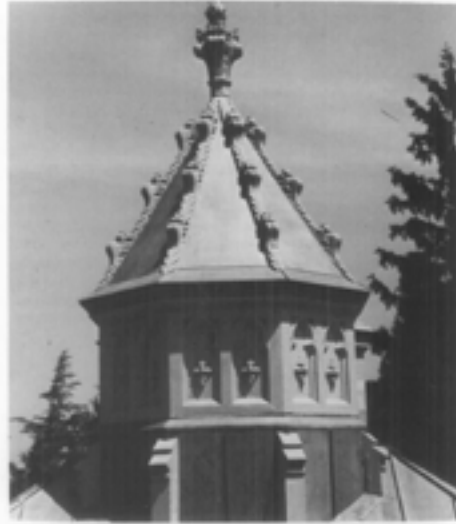
Decorative features such as cupolas require extra maintenance. The flashing is carefully detailed to promote run-off, and the wooden ribbing must be kept well-painted. This roof surface, which was originally tin plate, has been replaced with lead-coated copper for maintenance purposes. (Lyndhurst, Tarrytown, New York, photo courtesy of the National Trust for Historic Preservation)

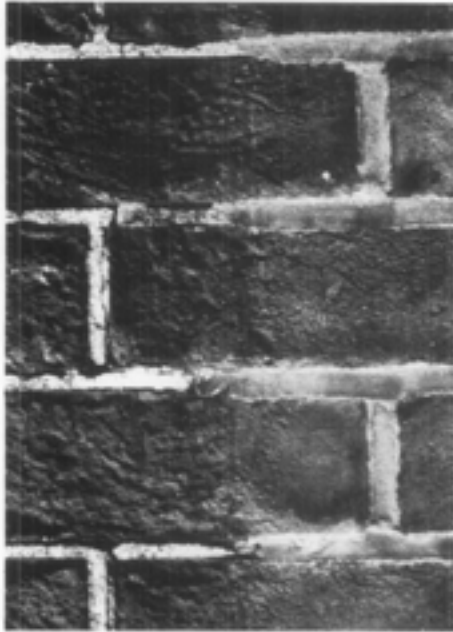
Abrasively Cleaned vs. Untouched Brick. Two brick rowhouses with a common facade provide an excellent point of comparison when only one of the houses has been sandblasted. It is clear that abrasive blasting, by removing the outer surface, has left the brickwork on the left rough and pitted, while that on the right still exhibits an undamaged and relatively smooth surface. Note that the abrasive cleaning has also removed a considerable portion of the mortar from the joints of the brick on the left side, which will require repointing.

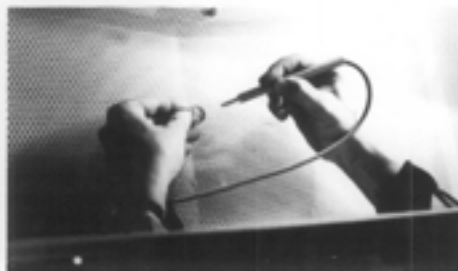
Micro-Abrasive Cleaning. This small, pencil-sized micro-abrasive unit is used by some museum conservators to clean small objects. This particular micro-abrasive unit is operated within the confines of a box (approximately 2 cubic feet of space), but a similar and slightly larger unit may be used for cleaning larger pieces of sculpture, or areas of architectural detailing on a building. Even a pressure cleaning unit this small is capable of eroding a surface, and must be carefully controlled.

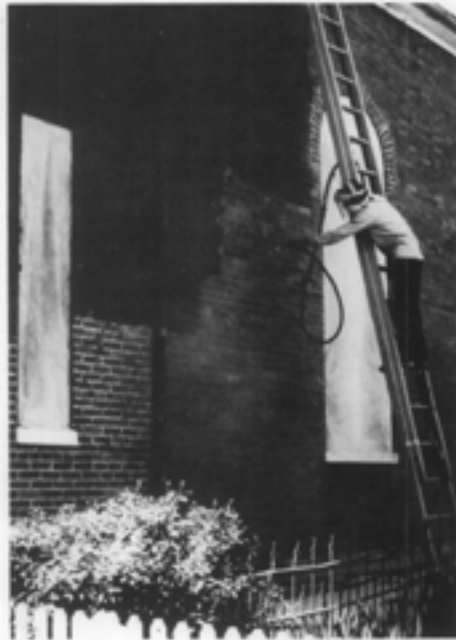
"Line Drop." Even though the operator of the sandblasting equipment is standing on a ladder to reach the higher sections of the wall, it is still almost impossible to have total control over the pressure. The pressure of the sand hitting the lower portion of the wall will still be greater than that above, because of the "line drop" in the distance from the pressure source to the nozzle. (Hugh Miller)

Pressure: The damaging effects of most of the variable factors involved in abrasive cleaning are self evident. However, the matter of pressure requires further explanation. In cleaning specifications, pressure is generally abbreviated as "psi" (pounds per square inch), which technically refers to the "tip" pressure, or the amount of pressure at the nozzle of the blasting apparatus. Sometimes "psig," or pressure at the gauge (which may be many feet away, at the other end of the hose), is used in place of "psi." These terms are often incorrectly used interchangeably.

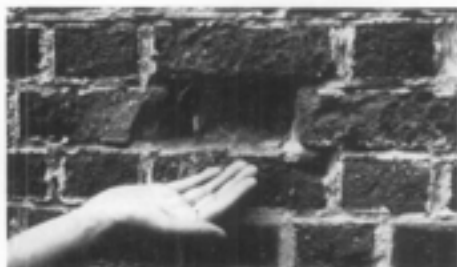
Spalling Brick. This soft, early 19th-century brick was sandblasted in the 1960s; consequently, severe spalling has resulted. Some bricks have almost totally disintegrated, and will eventually have to be replaced. (Robert S. Gamble)

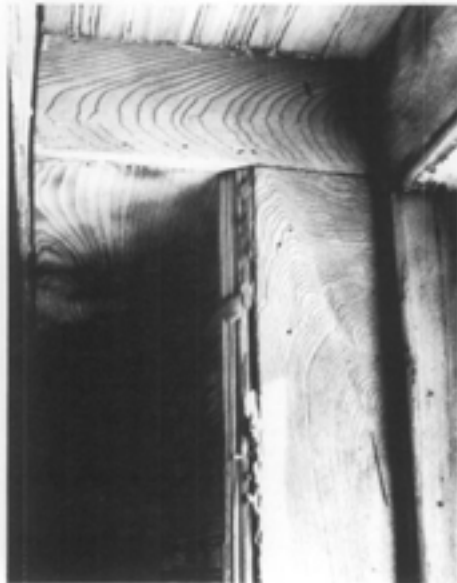
Abrasive Cleaning of Wood. This wooden windowsill, molding and paneling have been sandblasted to remove layers of paint in the rehabilitation of this commercial building. Not only is some paint still embedded in cracks and crevices of the woodwork, but more importantly, grit blasting has actually eroded the summer wood, in effect raising the grain, and resulting in a rough surface.

Wood: Most types of wood used for buildings are soft, fibrous and porous, and are particularly susceptible to damage by abrasive cleaning. Because the summer wood between the lines of the grain is softer than the grain itself, it will be worn away by abrasive blasting or power tools, leaving an uneven surface with the grain raised and often frayed or "fuzzy." Once this has occurred, it is almost impossible to achieve a smooth surface again except by extensive hand sanding, which is expensive and will quickly negate any costs saved earlier by sandblasting. Such harsh cleaning treatment also obliterates historic tool marks, fine carving and detailing, which precludes its use on any interior or exterior woodwork which has been hand planed, milled or carved.

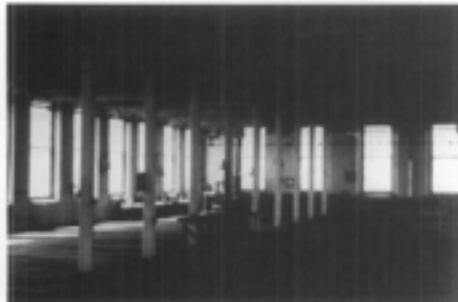
Permissible Abrasive Cleaning. In accordance with the Secretary of the Interior's Guidelines for Rehabilitation Projects, it may be acceptable to use abrasive techniques to clean an industrial interior space such as that illustrated here, because the masonry surfaces do not have significant design, detailing, tooling or finish, and the wooden architectural features are not finished, molded, beaded or worked by hand.

Interior spaces of factories or warehouse structures in which the masonry or plaster surfaces do not have significant design, detailing, tooling or finish, and in which wooden architectural features are not finished, molded, beaded or worked by hand, may be cleaned abrasively in order to remove layers of paint and industrial discolorations such as smoke, soot, etc. It is expected after such treatment that brick surfaces will be rough and pitted, and wood will be somewhat frayed or "fuzzy"

with raised wood grain. These nonsignificant surfaces will be damaged and have a roughened texture, but because they are interior elements, they will not be subject to further deterioration caused by weathering.

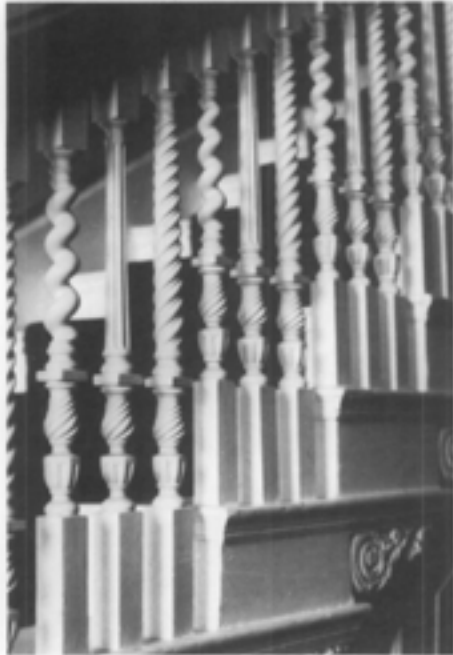
Do not Abrasively Clean these Interiors. Most historic residential and some commercial interior spaces contain finished plaster and wooden elements such as this stair balustrade and paneling which contribute to the historic and architectural character of the structure. Such interiors should not be subjected to abrasive techniques for the purpose of removing paint, dirt, discoloration or plaster.

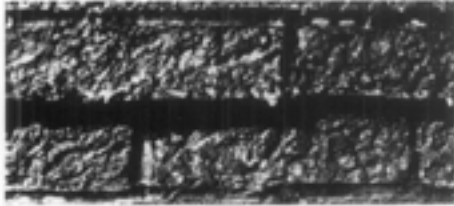
Hazards of Sandblasting and Surface Coating. In order to "protect" this heavily sandblasted brick, a clear surface coating or sealer was applied. Because the air temperature was too cold at the time of application, the sealer failed to dry properly, dripping in places, and giving the brick surface a cloudy appearance.

sealers reduce the transpiration of moisture, allowing salts to crystallize as subflorescence that eventually spalls the brick. If a brick surface has been so extensively damaged by abrasive cleaning and weathering that spalling has already begun, it may be necessary to cover the walls with stucco, if it will adhere.

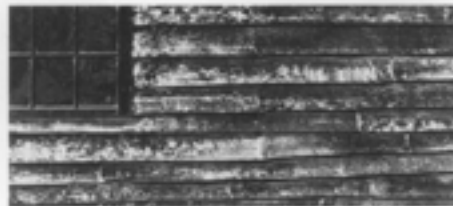
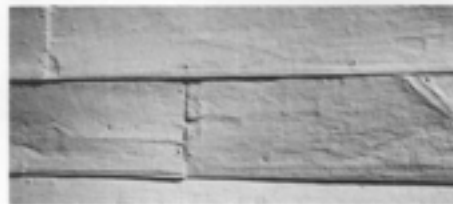
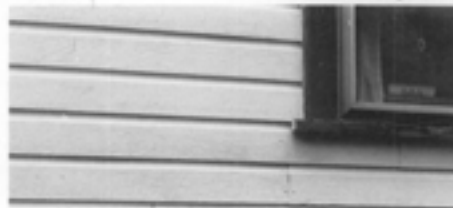
Historic wood sidings exhibit rich and varied surface textures. They range from hand-split clapboards of short lengths with feather-edged ends, to pit or mill sizen boards which can be beveled, rabbeted, milled, or beaded.

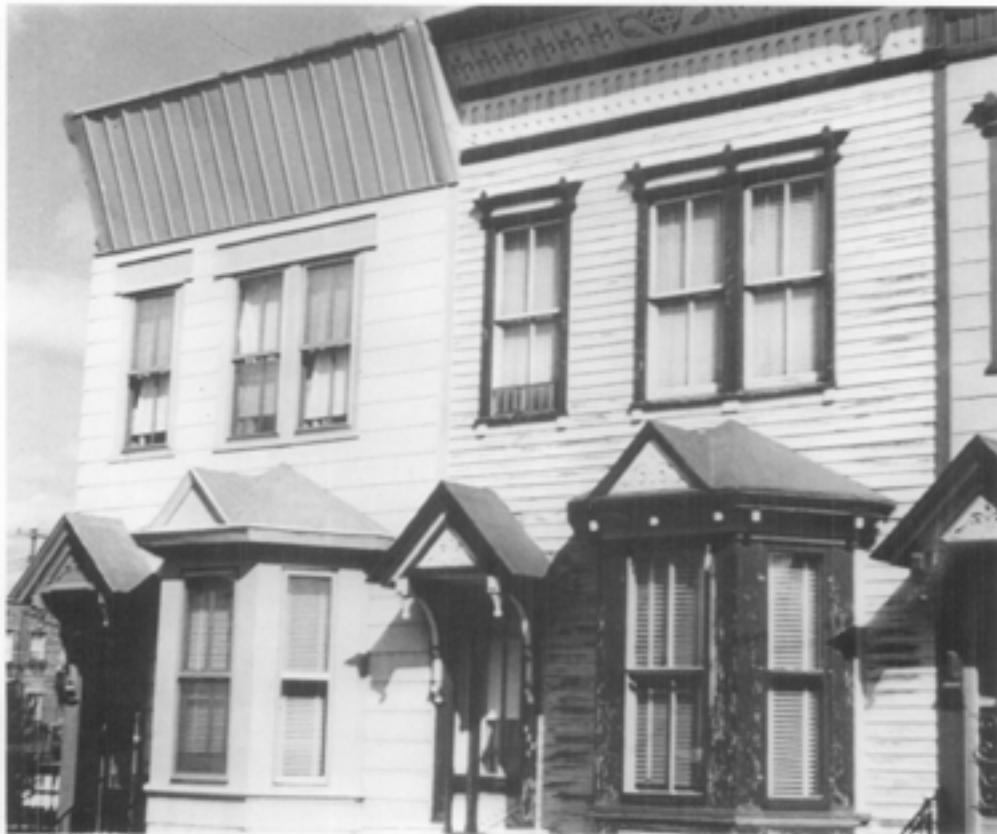
When a building is in need of maintenance, such as the house on the right which needs painting, some owners consider installing aluminum or vinyl siding. The result, like the house on the left, can be a complete loss of architectural character due to the covering of details (cornice), the removal of features (window trim), and a change of scale due to inappropriate siding dimensions.
